Naval Facilities Engineering Command, MIDLANT

Safety Lessons Learned Accident Abstract

Accident Type: NEAR MISS, CUT 1800 VOLT STREET LIGHT CABLE
Injury: None
Type of Work: EXCAVATING AND TRENCHING
Equipment: BACKHOE

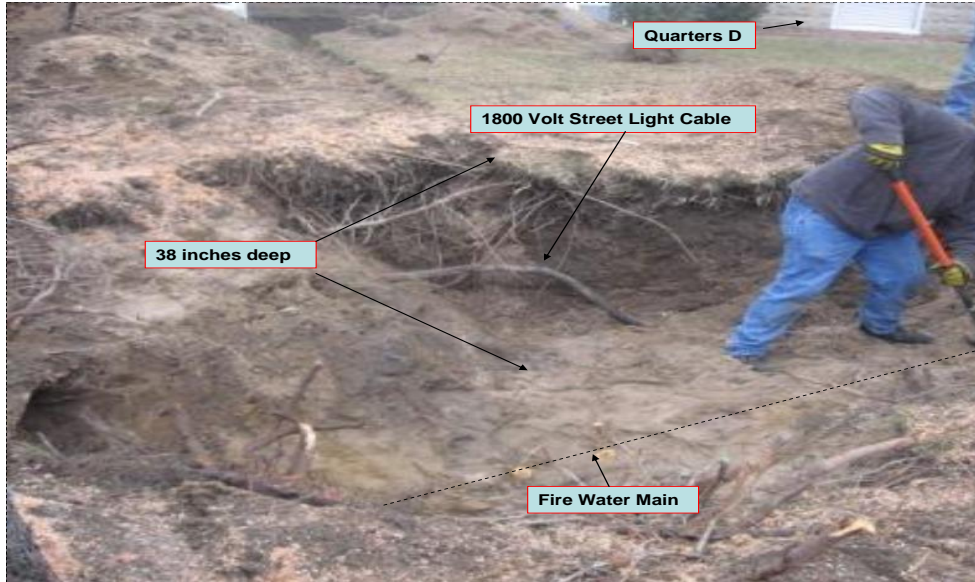
On Monday morning January 7, 2008 PWD PA Submitted a Dig Permit Request to the engineering department in an attempt to locate a water main break. The area was marked by engineering with red paint, red flags, blue paint and blue flags. After a brief discussion of the situation and safety issues the supervisor instructs his employees to begin hand digging near a foundation wall of Quarters D. No crack or break is discovered. Supervisor instructs employees to hand dig area under the blue and red markings. After less than an hour of hand digging and close to 3 foot deep a steel pipe is located, but no electric lines are found. Supervisor expresses this concern to the engineer. The engineer indicates that it is possible that he picked up a telephone line and not an electric line. The approval to use the backhoe is given. This is based on several hours of hand digging, finding no electric lines and a print indicating the electric is on the opposite side of the Quarters. More of the steel pipe is exposed and its route travels underneath a large tree. But, still no break is discovered or electric lines found. It was then decided to open the valves and let water into the pipe in an attempt to locate a flow and possibly the break. The valves are opened and water quickly fills the pit. Since the pit was full of water, a decision was made to use the bucket of the backhoe to remove the water from the pit. After removing six or seven buckets of water and making very little progress, it was then decided to dig a hole next to the pit instead of obtaining a pump, to allow the water level in the pit to drain into this newly dug hole. As they begin to dig with the backhoe, it cuts through a 1800 volt electric power line causing a loud and violent arc flash. Employees are shaken but no one is hurt. The employees immediately call the Electrical Supervisor. The Electrical Supervisor and electricians respond quickly and the power is locked and tagged out. This power was for a transformer that feed street lighting.

DIRECT CAUSE: Local One call Dig system not called.

INDIRECT CAUSE Engineer did not receive proper training on scoping equipment.

ROOT CAUSE: No site specific standard operating procedures.

LESSONS LEARNED: Develop Site Specific Standard operating procedures.
Train Engineers, Supervisors and Employees on proper procedures and equipment used.

ACTIONS UNDERWAY: PW6 is compiling SOPs from the PWDs to create a standardized SOP for MIDLANT
